## **SIMULATED RAINFALL EVALUATION OF REVEGETATION/MULCH EROSION CONTROL IN THE LAKE TAHOE BASIN—3: SOIL TREATMENT EFFECTS**<sup>Q9</sup>

M. E. GRISMER<sup>1</sup>\* AND M. P. HOGAN<sup>2</sup>

Revegetation, or other erosion control treatments of disturbed soil slopes in forested areas and along highways of the Lake Tahoe basin are directed at reduction of sediment loading to waterways reaching the lake. However, following treatment, little vegetation monitoring, or hydrologic evaluation has been conducted either to determine if the various treatments are successful or to assess the duration of erosion control anticipated in the field. Here, we build upon results from use of the portable rainfall simulator (RS) described in the first two papers of this series to evaluate cover and revegetation treatment effects on runoff rates and sediment concentrations and yields from disturbed granitic and volcanic soils in the basin. The effects of slope on rainfall runoff, infiltration and erosion rates were determined at several revegetated road cut and ski run sites. Rainfall simulation ( $\sim 60 \text{ mm h}^{-1}$ , approximating a 100-year, 15-minute storm) had a mean drop size of  $\si

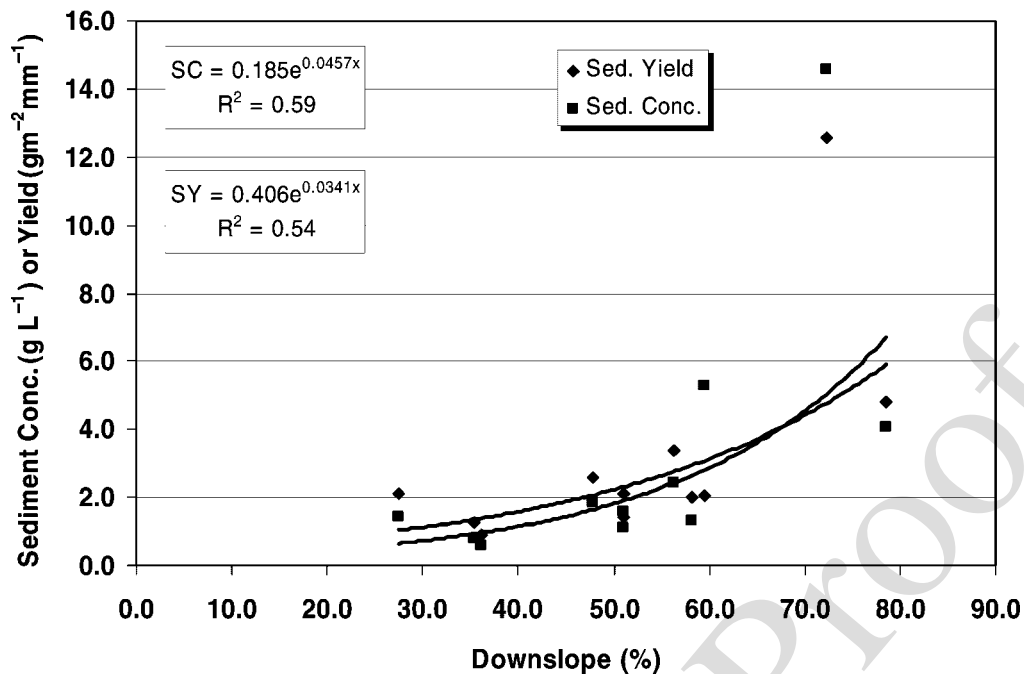
Figure 1. Runoff sediment concentration (SC) and yield (SY) from bare and native granitic soil plots as they depend on plot slope.

Table IV summarizes the rainfall simulation plot average results for all the granitic soil plots monitored in the basin including treated, native and bare soils. We briefly revisit analysis of runoff and sediment yield from bare and ‘native’ granitic soils followed by that from treated, disturbed soils so as to enable subsequent comparisons, or determinations of improvement in retaining sediment on the slope. Grismer and Hogan (2005) noted that bare (and native) granitic soil sediment yields were largely dependent on average downslope as shown in Figure 1 in which there is a roughly exponential increase in sediment yield (or concentration) with increasing slope. For example, sediment yields are roughly  $\sim 1 \text{ g m}^{-2} \text{ mm}^{-1}$  at  $\sim 35$  per cent slope increasing to  $2.5 \text{ g m}^{-2} \text{ mm}^{-1}$  at  $\sim 55$  per cent

slope and  $\sim 9 \text{ g m}^{-2} \text{ mm}^{-1}$  at  $\sim 75$  per cent slope. Native soil plots were on generally smaller slopes and sediment yields from these plots were less than, but undistinguishable from, that of disturbed bare soil plots on similar slopes. Generally, sediment yields from granitic soils were relatively small as compared to those from volcanic soils except on very steep slopes.

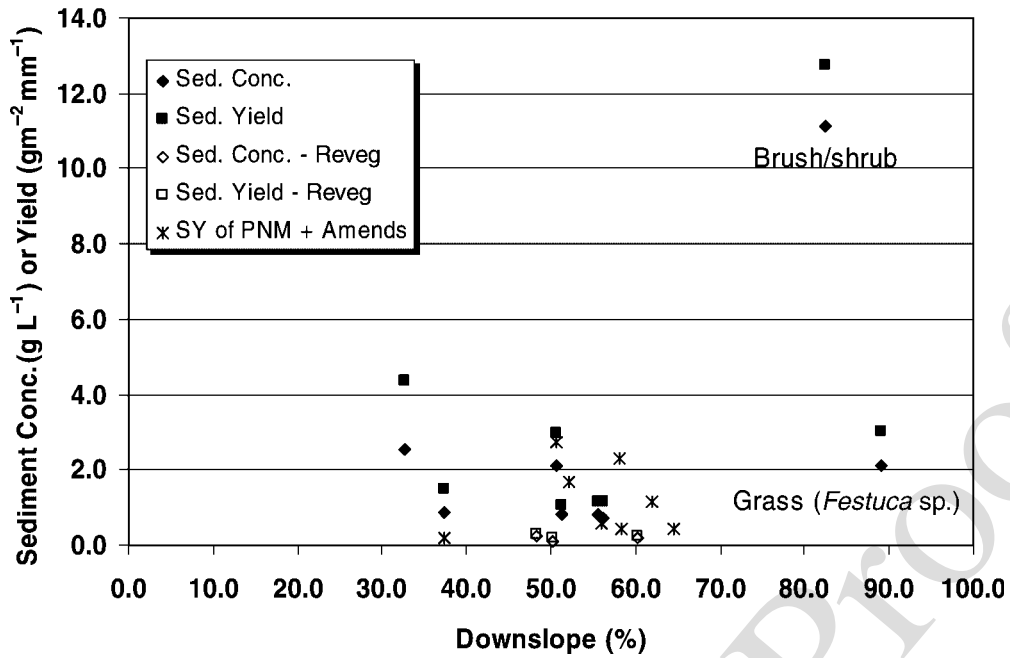
Figure 2. Runoff sediment concentration and yield from treated granitic soil plots as they depend on plot slope.

Granitic soil treatments ranged from simple pine-needle mulch (PNM) cover (common on 'native' soils), the use of soil amendments (e.g. compost, Biosol<sup>®</sup>, forest duff) and seeding/planting a grass cover, or some combination thereof. The 'standard' grass/*Festuca* sp. treatment generally involved hydroseeding a mixture of a fescue seed mix, fertilizer, wood fiber mulch and tackifier in a one-step process. These ingredients are mixed into a slurry and applied to the surface of a slope (see Table III). Soil amendment treatments included either tilling or complete mixing of compost into organic-poor soil to improve soil tilth, water-holding capacity, nutrient cycling and infiltration rates. PNM covers are commonly found on the forest floor in less disturbed areas and provide a long-lasting surface protection to raindrop impacts and subsequent splash-induced soil-particle detachment. Though not an actual 'treatment', at the Heavenly Valley ski run, we also took measurements in a 'brush' area on a steep slope. Figure 2 graphically illustrates sediment concentrations and yields from all of the granitic soil treatments as a function of average slope. Runoff from the steep 'brush' plots resulted in sediment concentrations and yields similar to that from bare soils at the same slope. Aside from runoff sediment values from the brush plot, there was no significant correlation (95 per cent level) between sediment concentrations or yields and slope in contrast to that from bare soil plots (see Figure 1). All of the remaining treatments, either individually or in combination, resulted in sediment concentrations and yields less than  $\sim 4 \text{ g L}^{-1}$  or  $\text{g m}^{-2} \text{ mm}^{-1}$ , respectively. Complete revegetation plus soil-rehabilitation treatments (e.g. Cave Rock) resulted in runoff sediment values similar to that from native plots and much less than  $1 \text{ g L}^{-1}$  or  $\text{g m}^{-2} \text{ mm}^{-1}$ . To better illustrate the effects of the complete revegetation treatments, we noted that most of the granitic-plot slopes were between 50 and 60 per cent and that averages from plots within this range could be compared. Taking averages of all plots in this slope range for each category of treatment we developed a comparison between bare, complete revegetation (i.e., Hogan reveg.), soil amendments and PNM and soil amendments and plants in terms of cumulative runoff and sediment at 15 minutes, sediment concentration and sediment yield for a  $\sim 55$  per cent slope as shown in Figure 3.

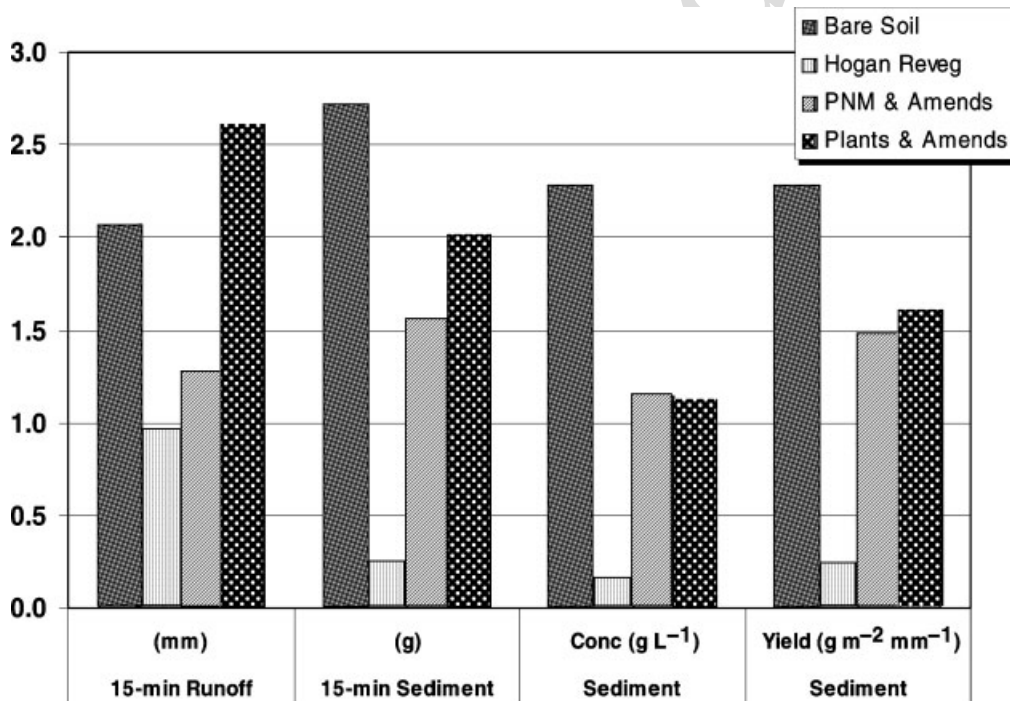
Figure 3. Average runoff sediment concentration and yield from two granitic sites with plot slopes between 50 and 60 per cent.

In comparing soil-treatment effects on runoff and sediment parameters for the granitic soils on a  $\sim 55$  per cent slope it is apparent that soil amendments with either a plant or PNM covers reduce sediment loss from the hillslope. Average sediment concentrations decline by approximately 50 per cent and sediment yields fall by over 30 per cent. However, despite such reductions, these values exceed those from 'native' soils. On the other hand, complete soil/plant restoration treatments reduced sediment concentration and yield by an order of magnitude resulting in values similar to, or less than, those from native soil plots.

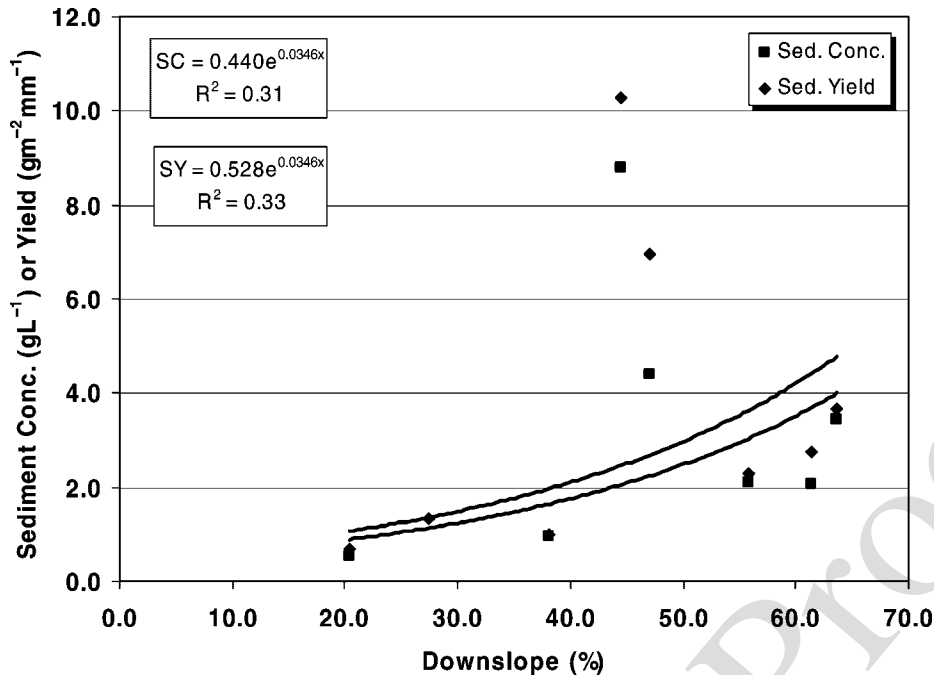
Figure 4. Runoff sediment concentration and yield from standard grass (*Festuca* sp.) treated volcanic soil plots as they depend on plot slope.

Runoff sediment concentrations and yields from the standard grass (*Festuca* sp.) treatments having grass cover in the range of 25 to 45 per cent showed a similar downslope dependence to that from bare soils, though regressions were less significant than those for bare granite soils (see Figure 4). Coincidentally, the exponential regression equations for sediment yields as a function of slope were practically the same for the volcanic grass (*Festuca* sp.) treatment and bare granitic soils with the exception that yields from the grass-treated volcanic soils are 30 per cent greater at any given slope. New straw cover resulted in lower sediment concentrations and yields than the standard

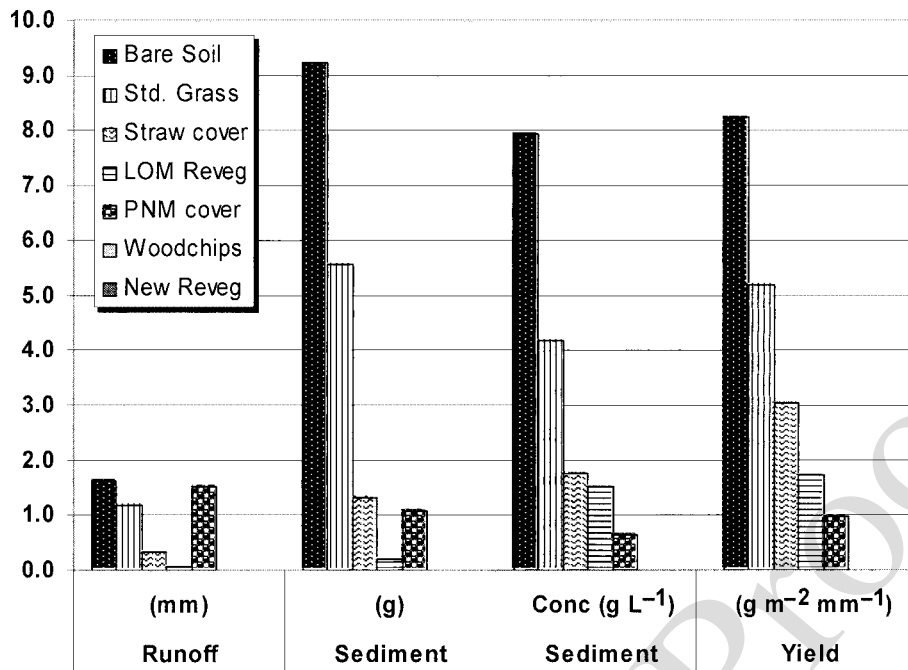
Figure 5. Comparison of cumulative runoff and sediment at 15 minutes and sediment concentration and yield from bare and treated volcanic plots on 50–60 per cent slopes (note that there is no runoff or sediment from the 'Woodchip' or 'New Reveg.' treatments).
